RE: March 7 and March 9, 2016 Clean Water Act Inspections

Please find enclosed the National Pollution Discharge Elimination System (NPDES) inspection reports for the U.S. Environmental Protection Agency's (EPA) March 7, 2016, and March 9, 2016 inspections of Platform Hillhouse and Platform A.

**Region 9 Enforcement Division
75 Hawthorne Street
San Francisco, CA 94105
INSPECTION REPORT**

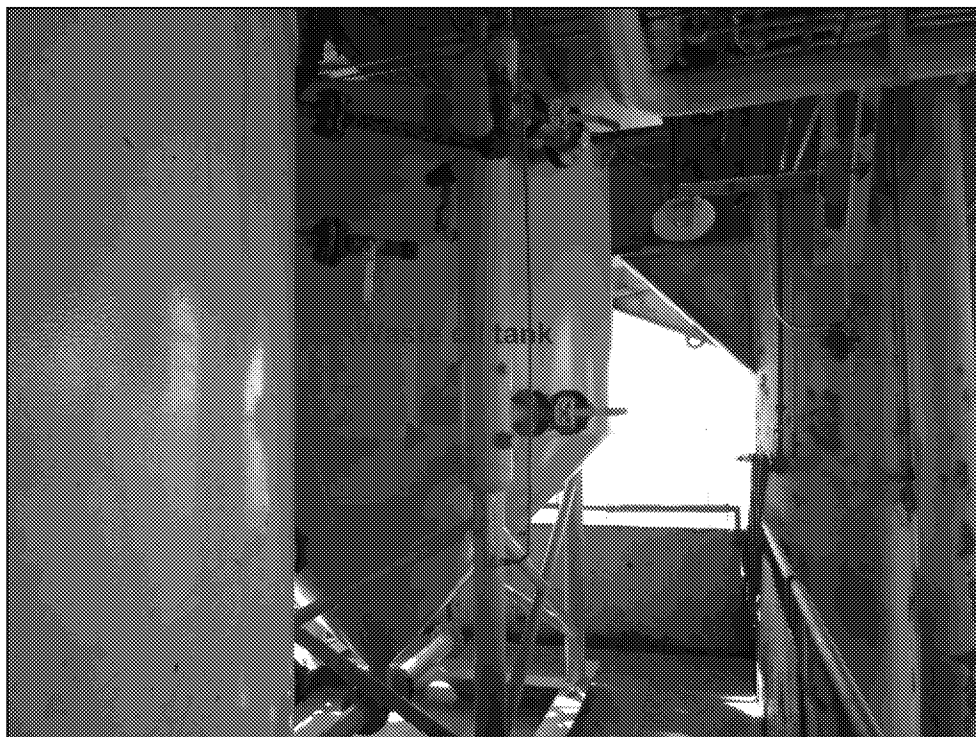
We observed the waste oil tank (refer to Photograph 2), which receives "commingled" deck drainage and fire control system wastewater prior to being pumped via waste oil pumps to DCOR's onshore Rincon treatment facility.

Photograph 2. View of waste oil tank utilized for collecting deck drainage and fire control system water prior to being pumped to DCOR's onshore Rincon treatment facility.

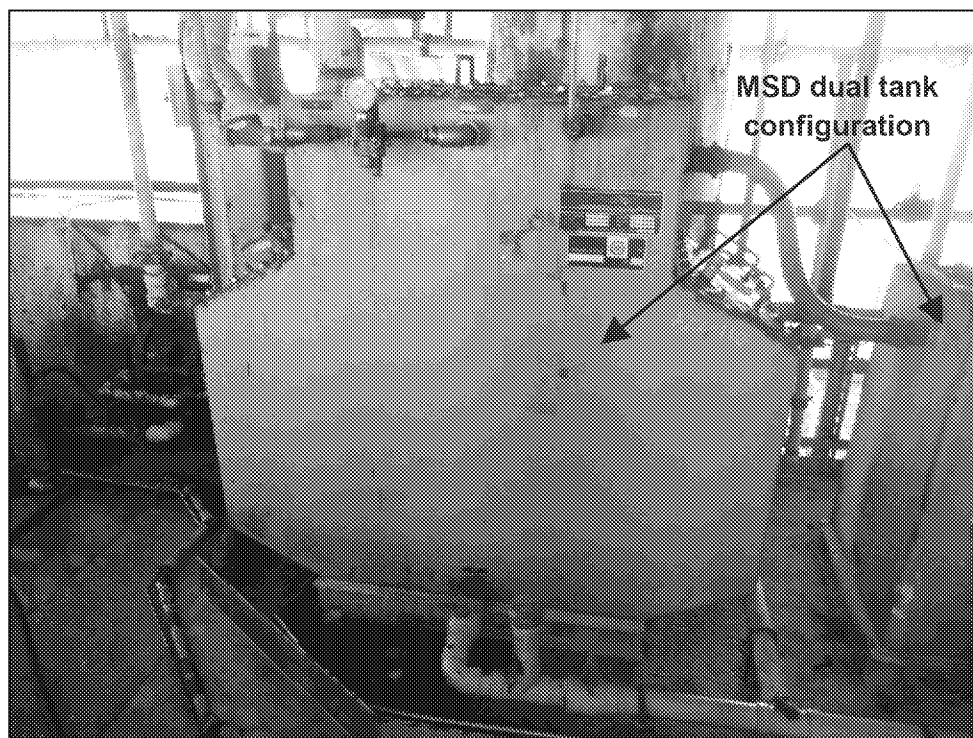
We observed the Facility redFox® MSD used to treat sanitary (black water) wastes (Discharge 005) prior to being discharged to the Pacific Ocean (Discharge 005) (refer to Photographs 5 and 6). The redFox® MSD unit was stamped with a manufacture date of June 29, 2009.

Based on a review of the Discharger's 2014 and 2015 annual MSD inspection records, we observed that the MSD unit did not meet total suspended solids (TSS) and total and fecal coliform USCG "appropriate standards" for MSD effluent per 40 CFR Part 140.3(d) for samples collected on December 14, 2015 (refer to Exhibit 4). Specifically, the Discharger's contract laboratory analytical results for the MSD effluent samples collected on December 14, 2015, for TSS (220 mg/L) and total coliform (4,600 MPN/mL)/*E.coli* (380 MPN/mL) were greater than 150 mg/L and 200 MPN/mL, respectively. This total coliform analytical result was 23 times greater than the USCG appropriate standard. Refer to Exhibit 4 and Exhibit 5 that includes:

We also noted that the Discharger had not inspected the internal media bed and media chambers annually as stated in the manufacturer's specifications. We also observed in the Discharger's 2014 and 2015 annual Facility MSD inspection reports that inspections of the MSD unit's interior was not performed due to "bolted hatches" (refer to Exhibit 4 Page 2). However, the redFox® FoxPac manufacturer installation, operation, and maintenance manual obtained from redFox® post-inspection recommends that the interior media bed and media chamber be inspected and cleaned annually. It does not appear that the Discharger performed the recommended media bed and media chamber inspection and cleaning for the MSD unit in accordance with manufacturer's recommendations.

Photograph 5. View of redFox® environmental marine sanitation device Fox Pac Model No. RF-500-FP, Serial No. 4873 used to treat sanitary wastes.

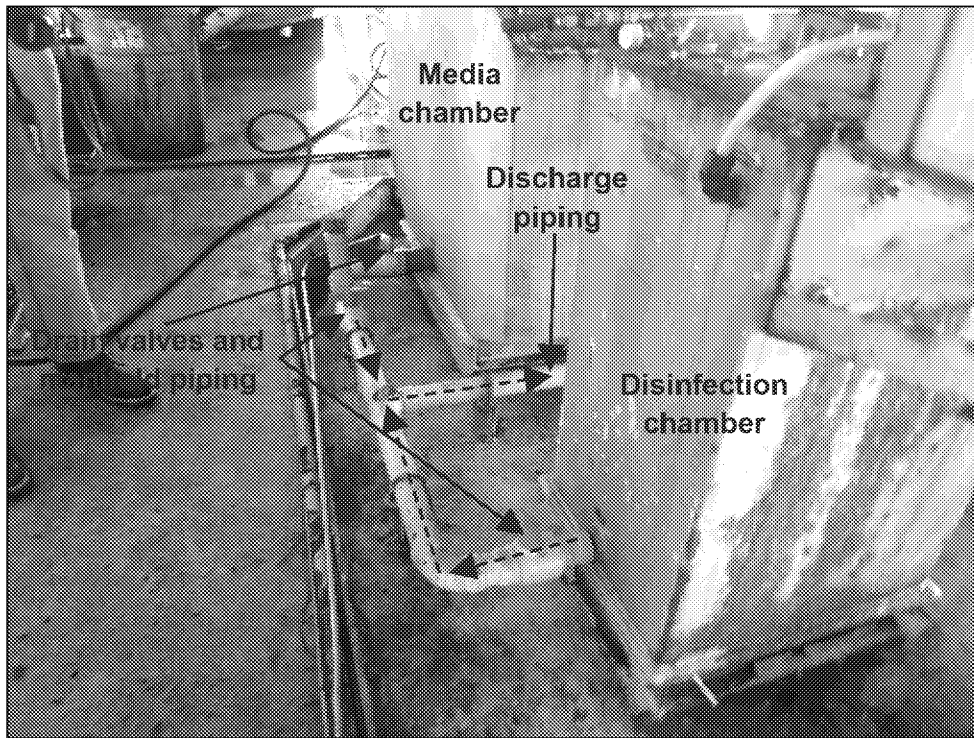
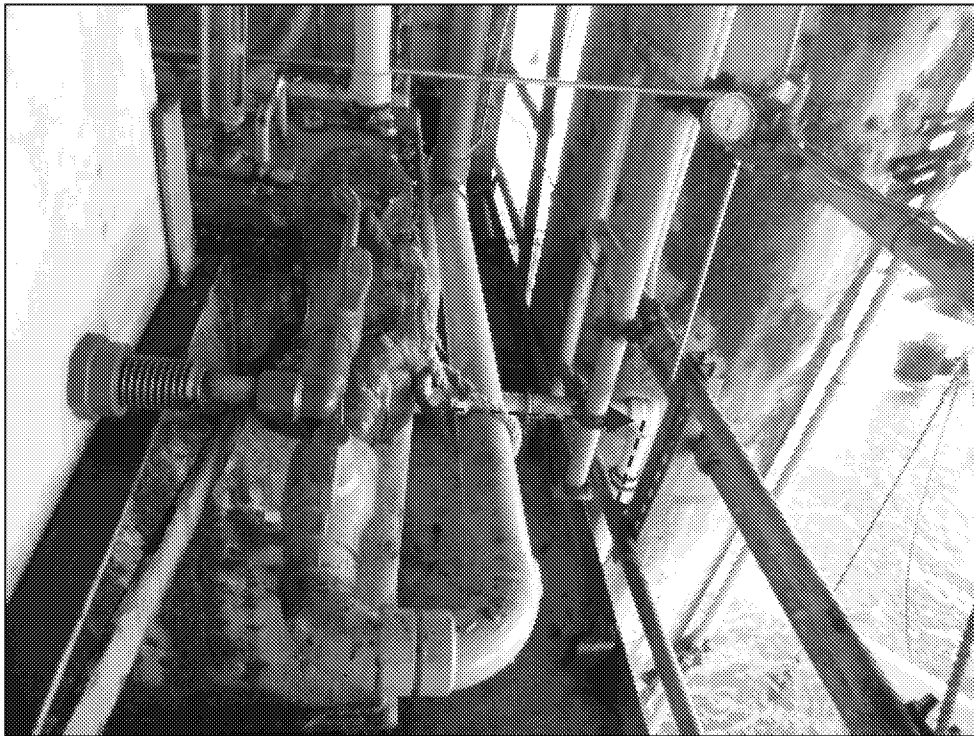
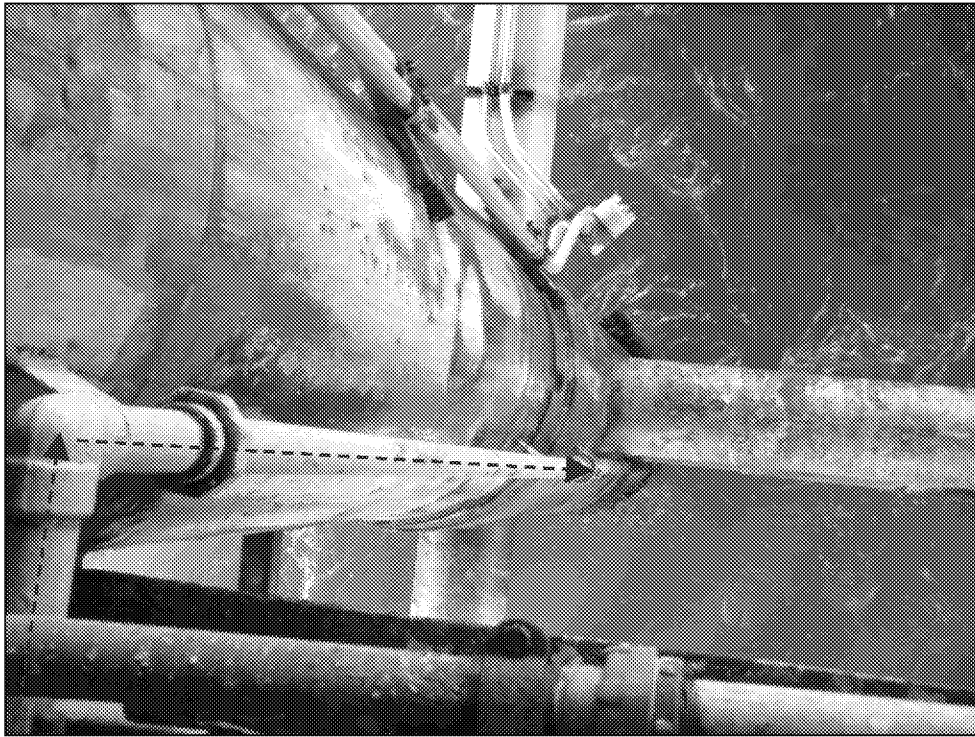
We observed that the Facility MSD unit was equipped with drain manifold and valves between the media chamber and disinfection chamber with the drain piping discharging directly to the Pacific Ocean (refer to Photographs 7, 8, and 9). At the time of the inspection all chamber drain valves were closed and no discharge was observed from the discharge piping to the Pacific Ocean. Facility representatives did not know at the time of the inspection, if any discharges ever occurred from the MSD unit media and disinfection chambers via this discharge piping.

Photograph 7. View of MSD unit media chamber and disinfection chamber drain valves and manifold. Note that the drain valves were in the closed position at the time of the inspection.

Photograph 8. View of discharge piping from the MSD unit media and disinfection chambers, shown in Photograph 7.

Photograph 9. View of discharge piping outfall to the Pacific Ocean from the MSD unit media and disinfection chambers drain manifold piping.

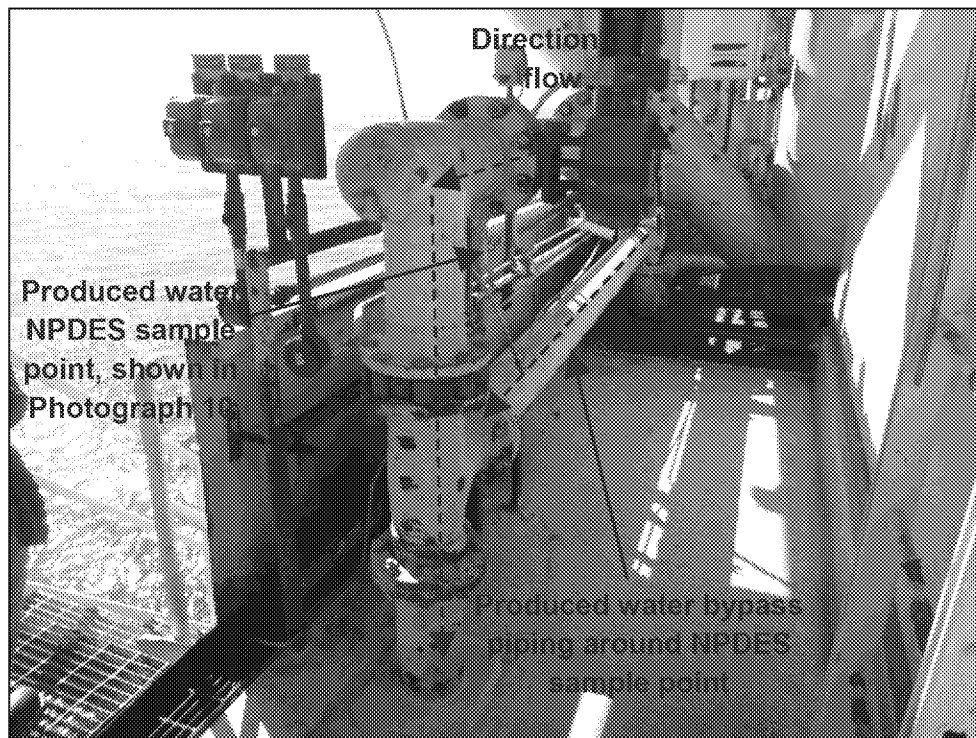
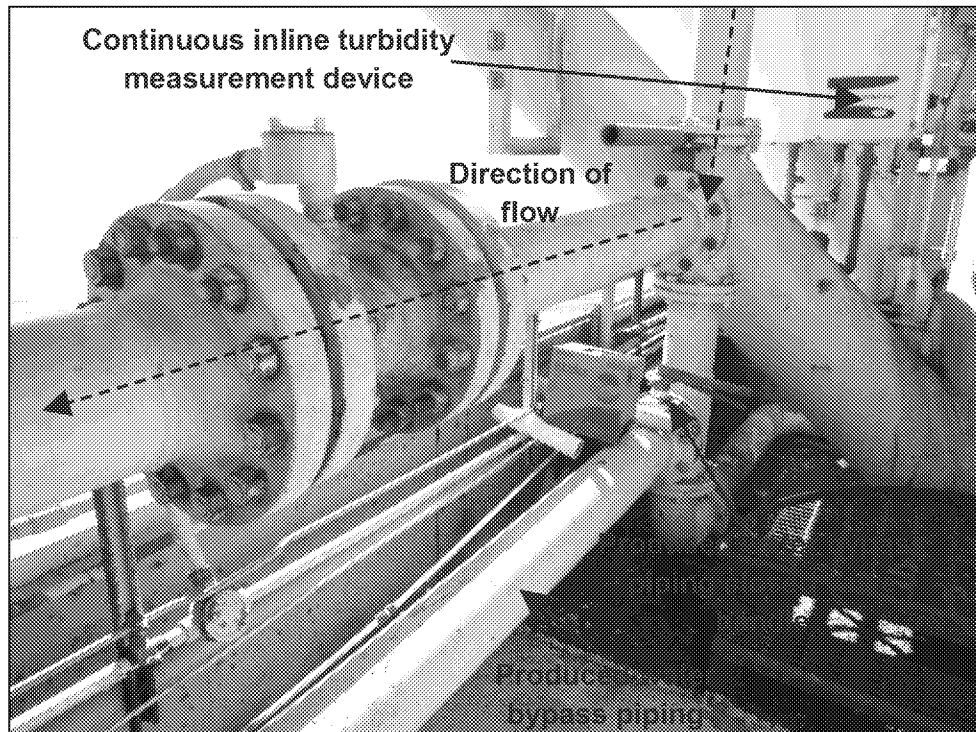
During the inspection, we observed a bypass line around the produced water NPDES oil and grease sample location (refer to Photographs 13 and 14). At the time of the inspection, the produced water NPDES sample point bypass piping was not in operation as indicated by the closed valve (refer to Photograph 14). Facility representatives were unaware of the frequency or reason for the bypass of the produced water oil and grease NPDES sample point.

Photograph 13. View of produced water bypass piping around NPDES sample point.

Photograph 14. Close-up view of produced water bypass piping around NPDES sample point, shown in Photographs 11. Note the bypass piping was not in operation at the time of the inspection, as indicated by the closed valve handle.

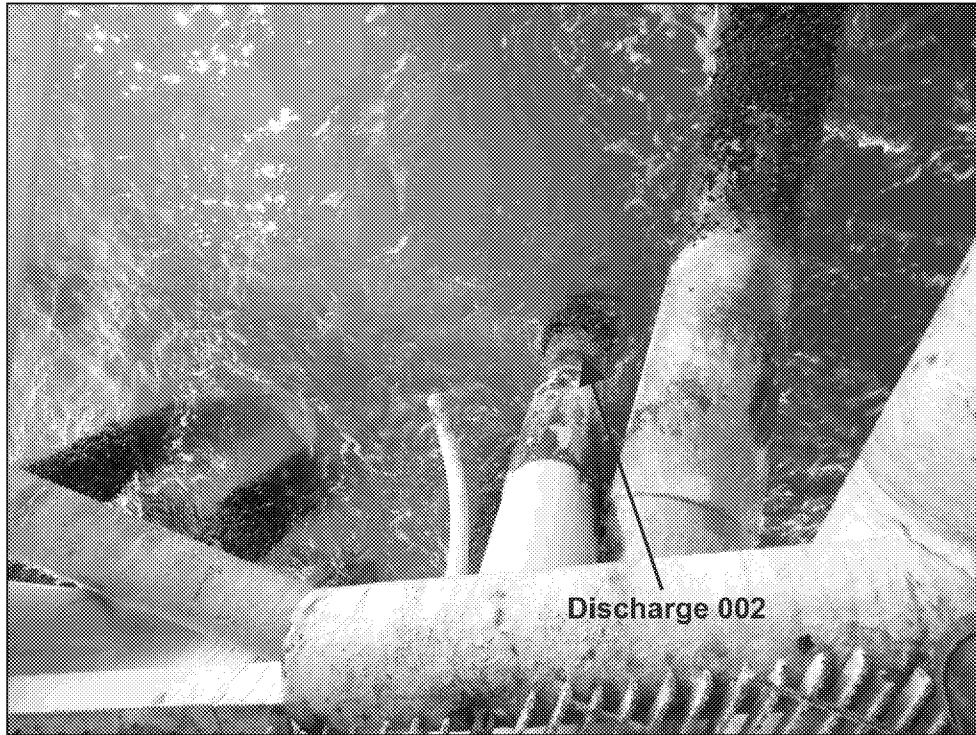
During the Facility walk through, we observed the Facility produced water treatment train. The Discharger's produced water (Discharge 002) NPDES sampling point is located at the discharge pipe off of the WEMCO. We viewed this discharge pipe as a component of the inspection (refer to Photographs 10, 11, and 12). Based on our observations during the inspection, the produced water NPDES oil and grease sample location appeared to provide representative samples; however, we observed a bypass line around the NPDES sample point during the inspection (refer to Photographs 13 and 14). We observed that the produced water NPDES sample point bypass piping was not in operation during the inspection, as indicated by the closed valve (refer to Photograph 14). The receiving water (Pacific Ocean) within the vicinity of the produced water discharge pipe was viewed and observed to be free of visually objectionable characteristics at the time of the inspection (refer to Photograph 15).

Photograph 15. View of the receiving water (Pacific Ocean) within the vicinity of Platform A NPDES produced water submerged outfall discharge pipe at the time of the inspection.

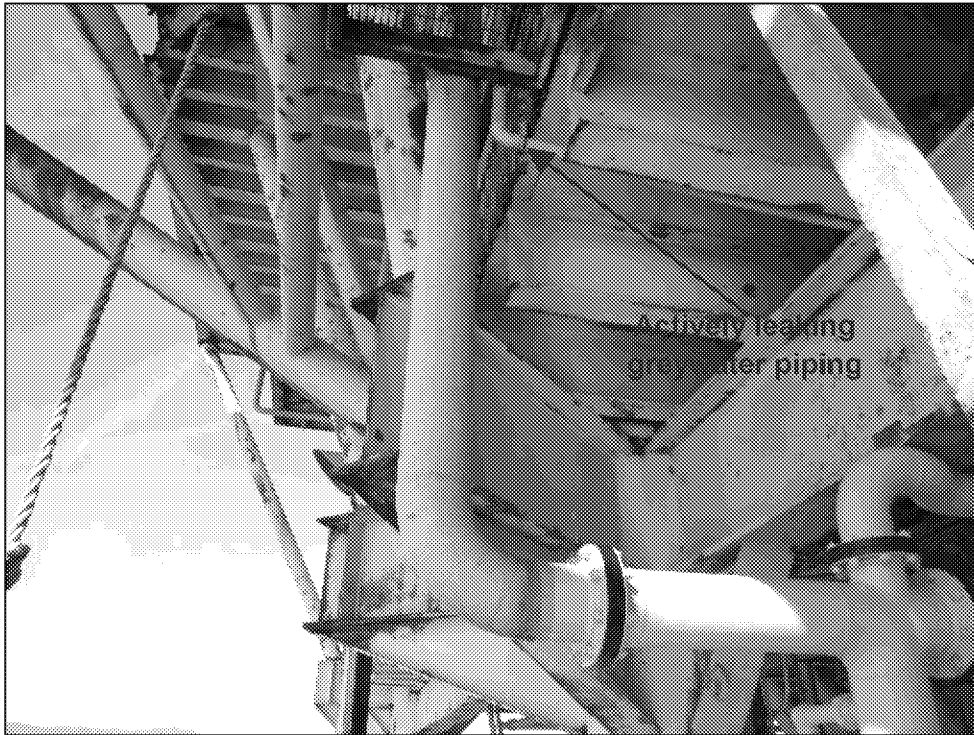
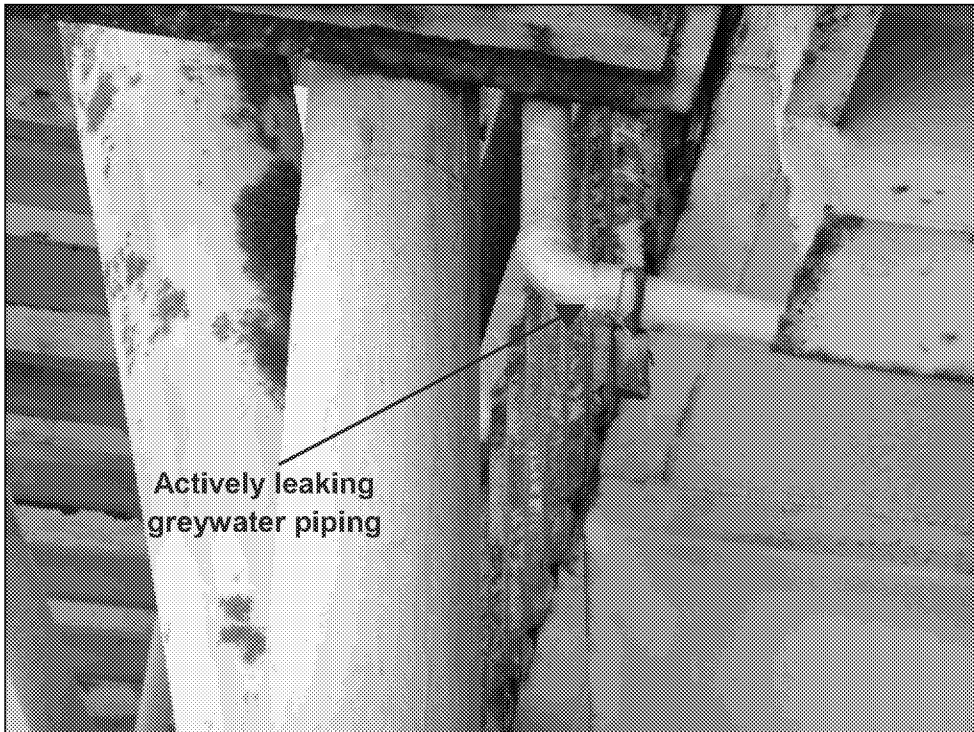
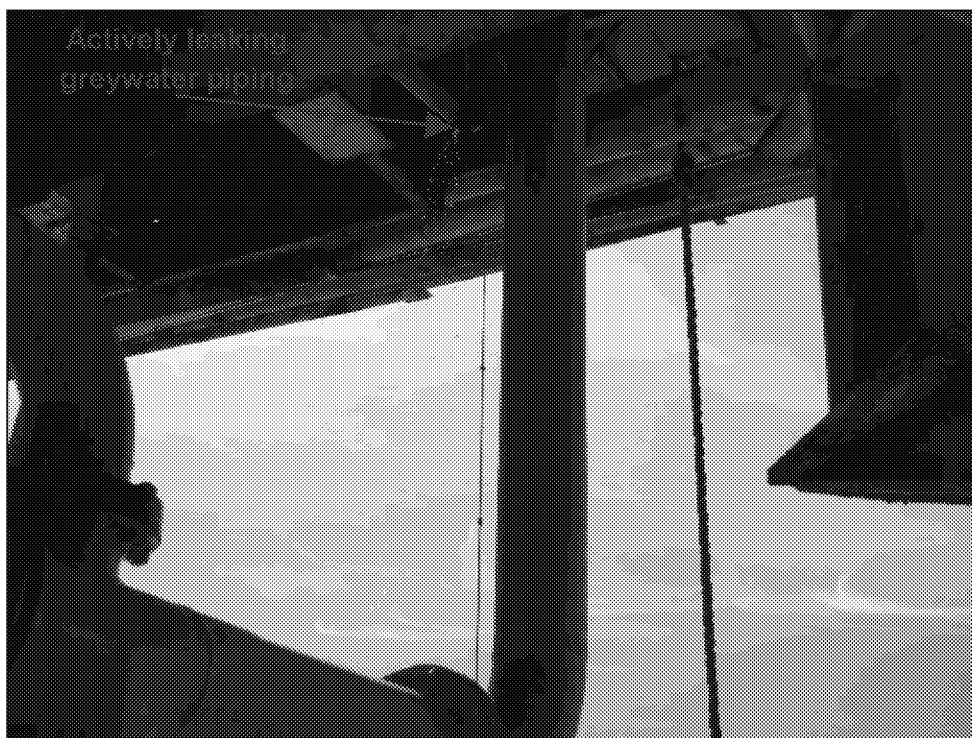
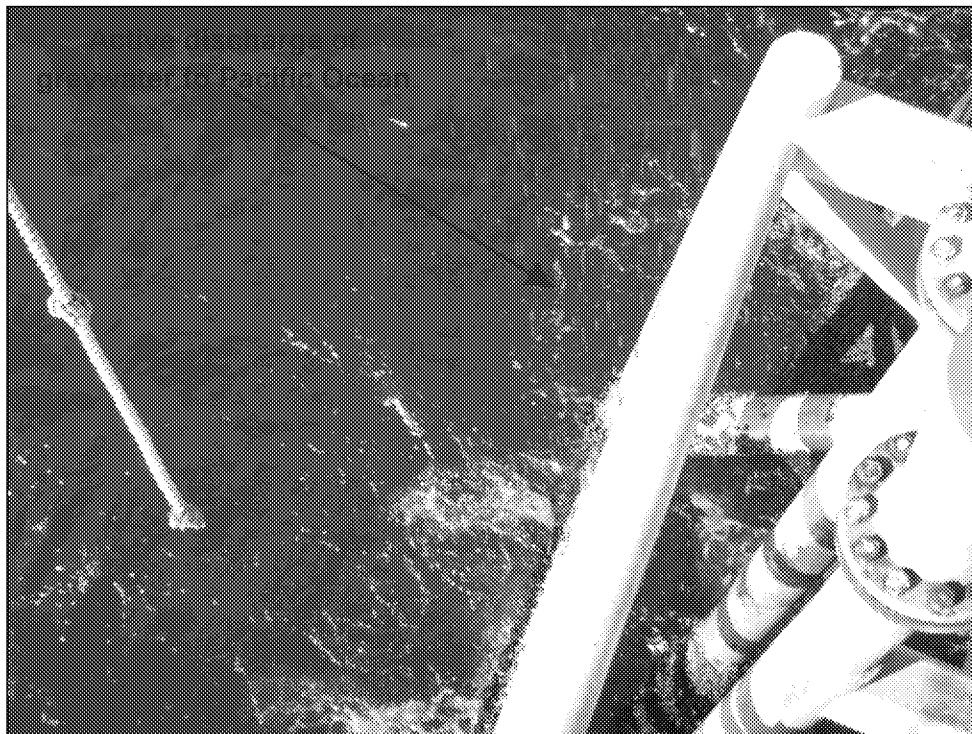
We observed an actively leaking domestic (greywater) piping discharging to the receiving water (Pacific Ocean) at the time of the inspection (refer to Photographs 17 through 20). Facility

representatives stated that the greywater piping leak appeared to be originating from the galley drain system.

We observed an active domestic (greywater) piping leak discharging to the receiving water (Pacific Ocean) at the time of the inspection (refer to Photographs 17 through 20). As a result of the leak, not all greywater was being discharge at the designated discharge location (Discharge 005). Facility representatives stated that the greywater piping leak appeared to be originating from the galley drain system. During the inspection, Mr. Rao stated that they would promptly address the greywater leak and notify EPA Region 9 once completed.

Photograph 17. View of the location of the active domestic (greywater) piping leak.

Photograph 18. Close-up view of active domestic (greywater) piping leak.

Photograph 19. Alternate view of active domestic (greywater) piping leak.

Photograph 20. View of receiving water (Pacific Ocean) in the vicinity of the active domestic (greywater) piping leak discharge. Note the droplets showering down in the photo from the greywater leak shown in Photographs 17, 18, and 19.

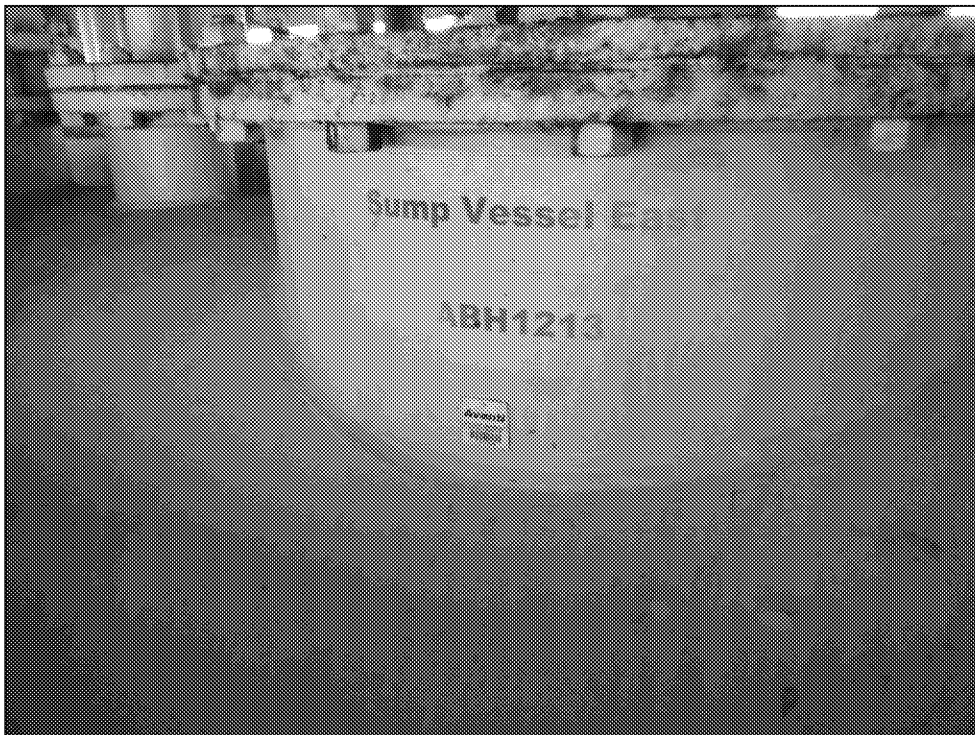
We observed the sump tank/vessel (refer to Photograph 2) located on the sump deck. We observed what appeared to be an active petroleum product leak from the pipe connection to the sump tank/vessel, which was actively running down the sides of the tank (refer to Photographs 15 and 16).

Photograph 2. View of sump tank/vessel located on the sump deck, which temporarily stores deck drainage and fire control system water prior to being commingled with the produced water treatment train.

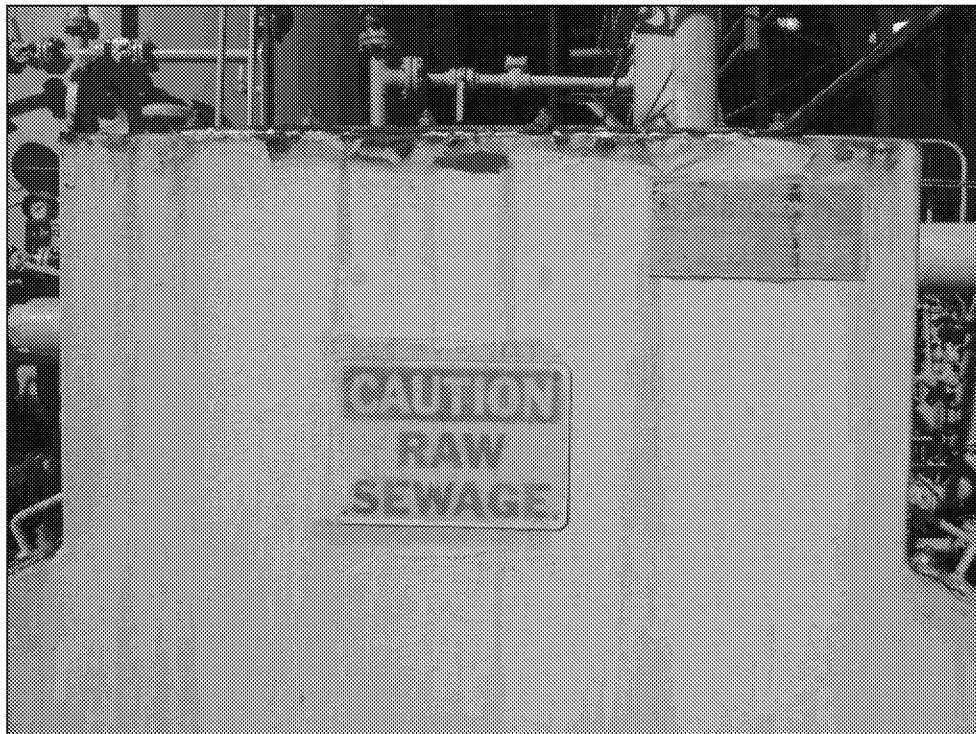
We observed the Facility redFox® MSD used to treat sanitary (black water) wastes (Discharge 005) prior to being discharged to the Pacific Ocean (refer to Photographs 6 and 7). The redFox® MSD unit was stamped with a manufacture date of July 2, 1997.

Based on a review of the Discharger's 2014 and 2015 annual Facility MSD inspection records (refer to Exhibit 3), we observed that the MSD unit did not meet total and fecal coliform USCG "appropriate standards" for MSD effluent per 40 CFR Part 140.3(d) for samples collected on December 15, 2014 (refer to Exhibit 4 Page 2). Specifically, the Discharger's contract laboratory analytical results for the MSD effluent samples collected on December 15, 2014, for total coliform and *E.coli* were greater than 24,000

We also noted that the Discharger had not inspected the internal media bed and media chambers annually as stated in the manufacturer's specifications. We also observed in the Discharger's 2014 and 2015 annual Facility MSD inspection reports that inspections of the MSD unit's interior was not performed due to "bolted hatches" (refer to Exhibit 3 Page 2). However, the redFox® FoxPac manufacturer installation, operation, and maintenance manual obtained from redFox® post-inspection recommends that the interior media bed and media chamber be inspected and cleaned annually. It was unclear if the Discharger performed the recommended media bed and media chamber inspection and cleaning for the MSD unit in accordance with manufacturer's recommendations and the proper operation and maintenance provision of the Permit. Specifically, the Discharger's 2014 and 2015 annual Facility MSD inspection reports stated that the interiors were not inspected; however, the report stated that the unit was cleaned in April 2014 and March 2015. It was not clear to us how the MSD unit was cleaned if the media and disinfection chambers were not inspected.

Photograph 6. View of the redFox® environmental marine sanitation device (MSD) Fox Pac Model No. RF-1000-FP, Serial No. 3709 used to treat domestic and sanitary wastes.

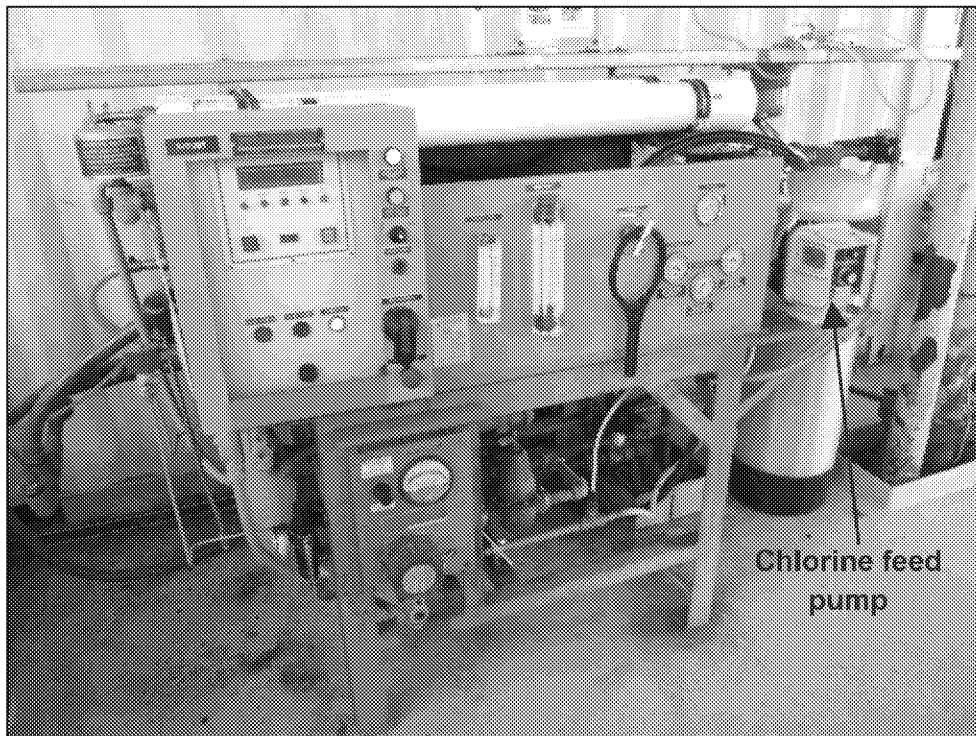
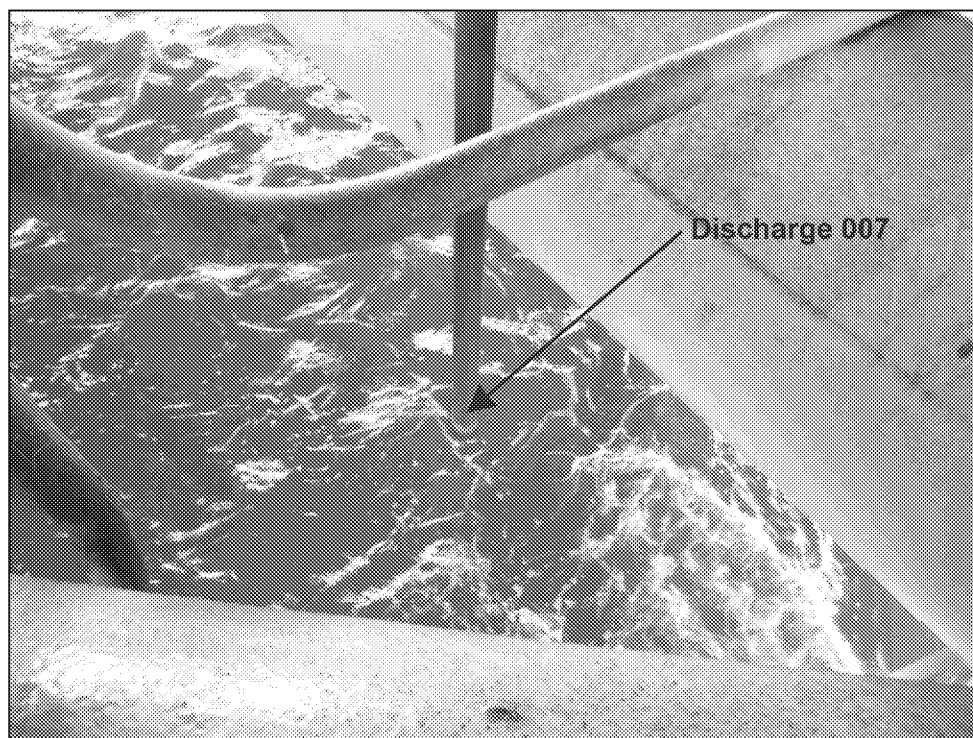
We observed the desalination unit and waste stream discharge location (Discharge 007) at the time of the inspection (refer to Photographs 8 and 9). Because the desalination unit was not in use at the time of the inspection, it was unknown if the Discharger conducted daily daylight hour monitoring by visual observation (for foam or floating solids) in the vicinity of the desalination unit waste stream discharge (Discharge 007) when the desalination unit was in use.

We observed that the Facility representatives were not familiar with the frequency of the desalination unit's use or the associated waste stream discharges to the Pacific Ocean (Discharge 007). Because the desalination unit was not in use at the time of the

Photograph 8. View of the desalination (i.e., reverse osmosis) unit located on the drill deck. According to onsite Facility representatives, the desalination unit is periodically used to provide water for sinks and showers on the platform.

Photograph 9. View of the desalination (i.e., reverse osmosis) unit wastes discharge point (Discharge 007) to Pacific Ocean.

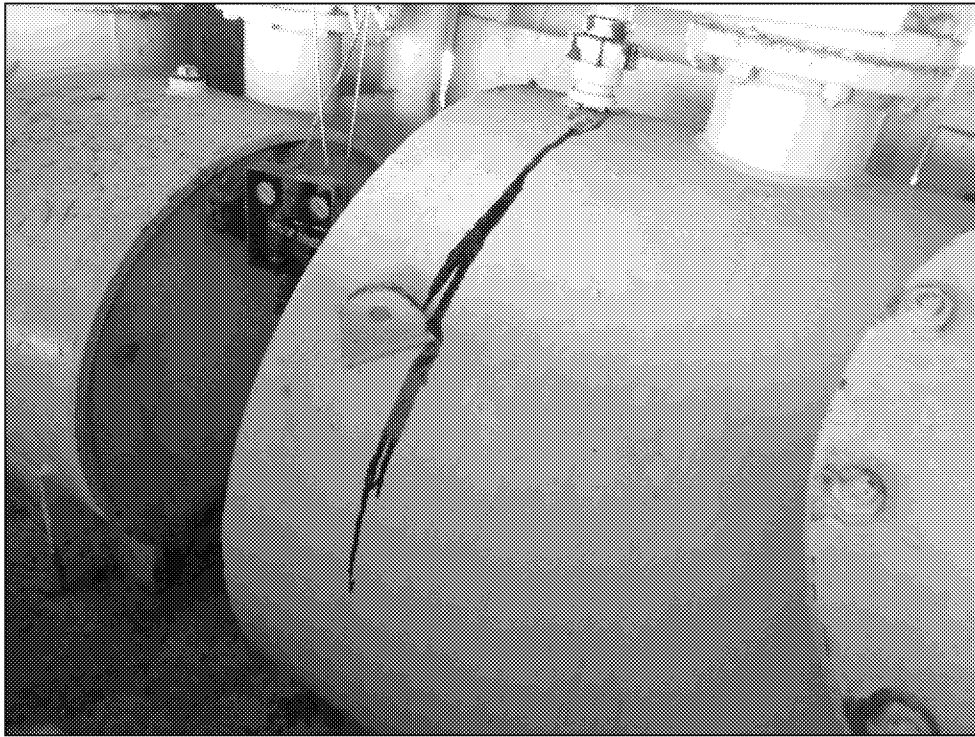
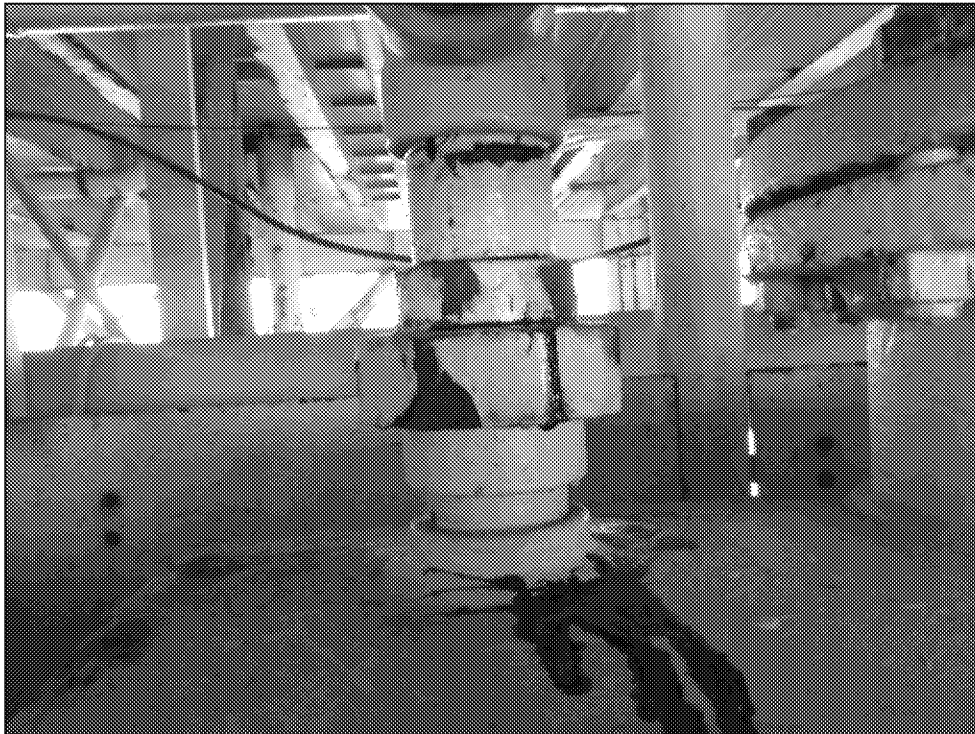
- a. We observed what appeared to be an active petroleum product leak from a pipe connection running down the side of the sump tank/vessel (refer to Photographs 2, 15, and 16). The sump tank/vessel receives deck drainage and fire control system water prior to being pumped into the onsite repurposed platform Henry treater, now known as the settling tank (refer to Photograph 3). The deck drainage and fire control system water are subsequently commingled with the produced water treatment process just upstream of the WEMCO units. This petroleum product leak was not cleaned up or remediated at the time of the inspection.

Photograph 15. View of petroleum product leak from pipe connection to sump tank/vessel, shown in Photograph 2.

Photograph 16. Close-up view of petroleum product leak on pipe connection to sump tank/vessel, shown in Photograph 15.
